**TX49/H4 Core Product
Specification Update
Rev. 1.6**

TOSHIBA CORPORATION

Document No. BFE0018E

January 2011

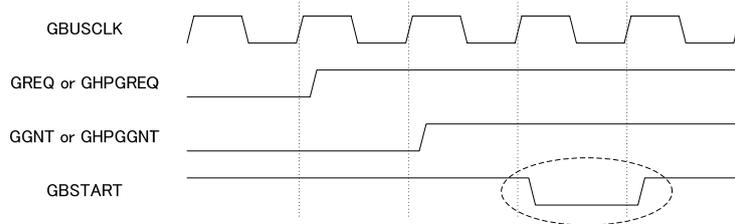
For dumping of a general-purpose register (GPR) by the EJTAG ICE, a coprocessor bus cycle of the TX49 core is used to transfer the GPR value to the integrated Debug Support Unit (DSU). A coprocessor bus cycle should not be requested while an external bus master assumes ownership of the G-Bus using the GREQ/GGNT or GHPGREQ/GHPGGNT signals for ET concurrency operations. Otherwise, one cycle after the TX49 core regains G-Bus ownership, GBSTART is asserted for one cycle improperly without an assertion of GRD or GWR.

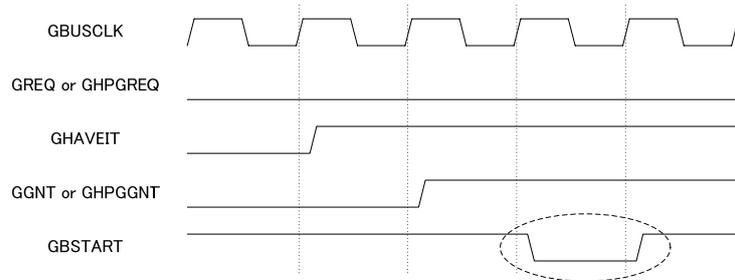
This problem occurs when the external bus master gives up the G-Bus not only by deasserting the GREQ or GHPGREQ signal but also by deasserting the GHAVEIT signal.

When this problem happens, the address and data buses have values according to the protocol of the coprocessor bus cycle in progress. Therefore, the opcode of the CTC0 or CFC0 instruction (0x0_40**_****) is placed on the address bus (GAFM35-GAFM0), and the value of the GPR specified by the CTC0 instruction is placed on the data bus.

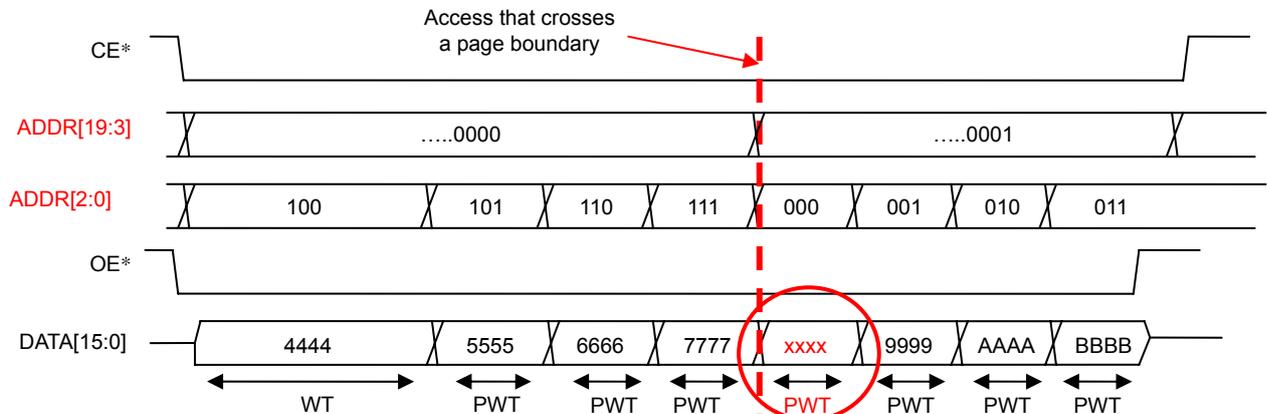
Therefore, depending on the starting address, the wait cycle count of the access that crosses a page boundary might be determined by the EBCCRn.PWT value.

Though an access to the NOR Flash crosses a page boundary, the wait cycles are not properly inserted as programmed in EBCCRn.WT. (The wait cycles are inserted as programmed in EBCCRn.PWT.) Therefore, the access cycle does not meet the required NOR Flash access time, and the first data of a new page cannot be read properly.

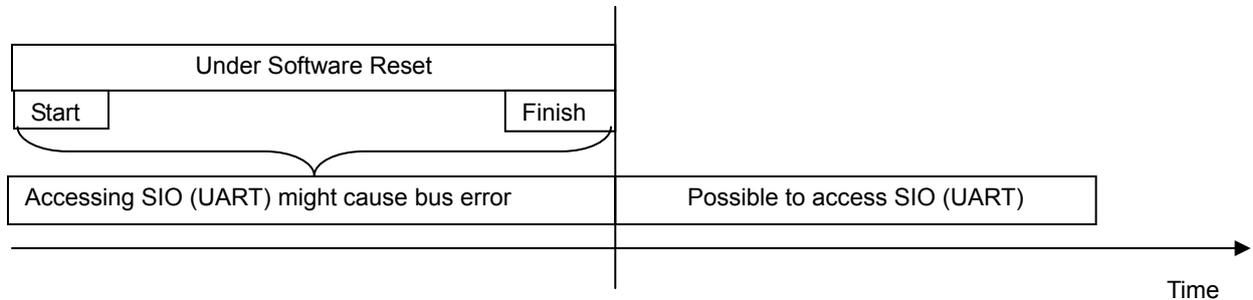
SIO (UART) can be initialized (Software Reset) by writing 1'b1 into the SWRST (bit 15) of the FIFO control register (SIFCR). If any register of SIO is accessed before completion of Software Reset, bus cycle is hung up and bus error is caused. A polling SWRST causes the same problem.

When Software Reset is executed by writing 1'b1 into the SWRST (bit 15) of the FIFO control register (SIFCR), it might cause bus hung up and bus error.

The following sequence of actions must be performed for Software Reset and accessing SIO (UART).
