## **Important Notices**

**TOSHIBA Microcontrollers TLCS-870 Family**  
**TLCS-870/C1 Series**

## Restrictions on the Voltage Detection Circuit

## Datasheet Corrections regarding the 16-Bit Timer Counter

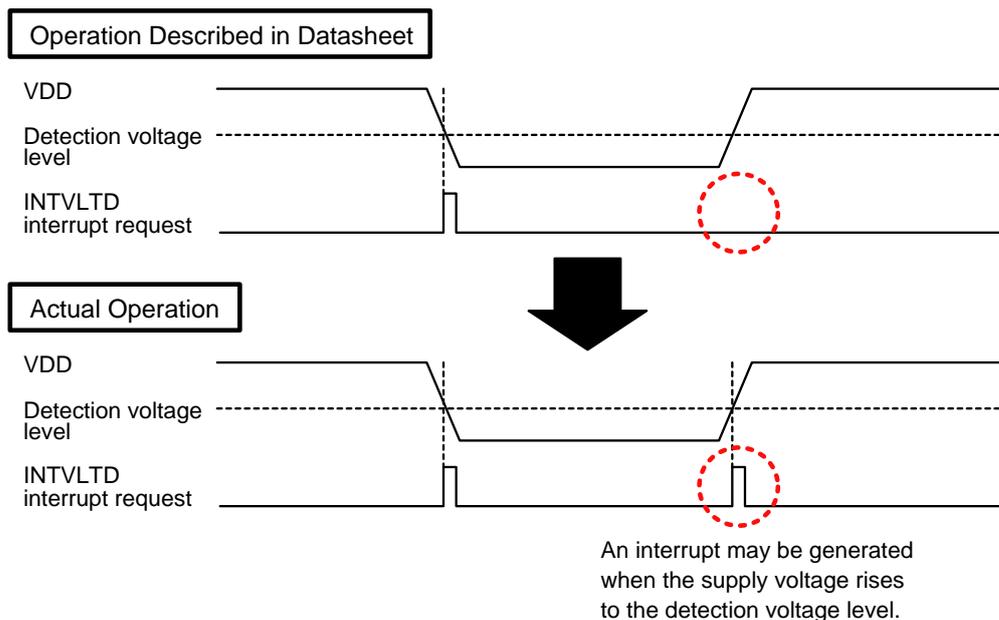
When interrupt generation is enabled in the voltage detection circuit, an INTVLTD interrupt request may be generated not only when the supply voltage falls to the detection voltage level, but also when it rises to the detection voltage level.

In ICE mode of the In-Circuit Emulator (TMP89C900), no interrupt request is generated when the supply voltage rises to the detection voltage level. Therefore, with products supporting the In-Circuit Emulator (TMP89C900), the interrupt generation operation may differ between the development tool and the actual product.

Do not use the INTVLTD interrupt for voltage detection. The voltage level should be regularly checked using other timing such as the execution cycle of the main program. VDCR1<VDxSF> (x=1, 2) can be used to check the voltage level. However, if the operating voltage is near the detection voltage, the VDCR1<VDxSF> value may become unstable. It is recommended that VDCR1<VDxSF> be tested multiple times to determine the voltage level.

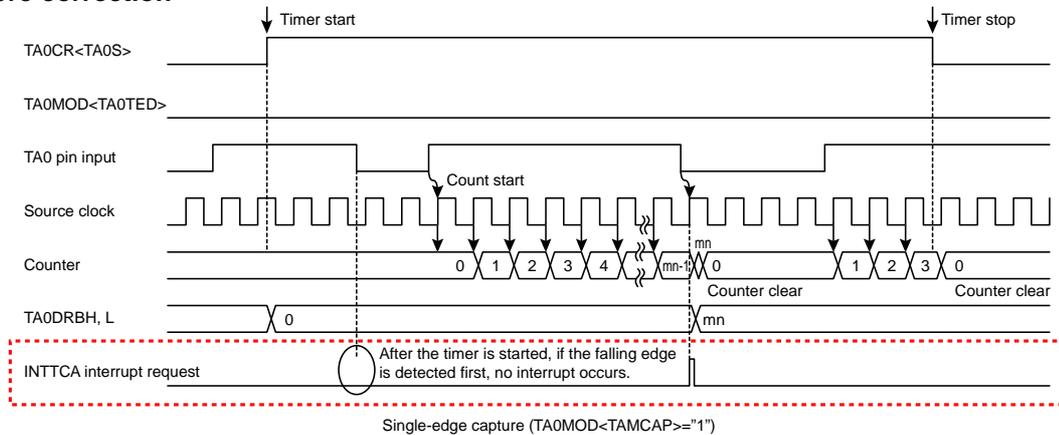
#### Before correction

1. The timing diagram for single-edge capture indicates that no interrupt request occurs at the first count start edge and the second count start edge after the timer is started. This should be corrected so that an interrupt request occurs at the first count start edge and the second count start edge, as shown below.

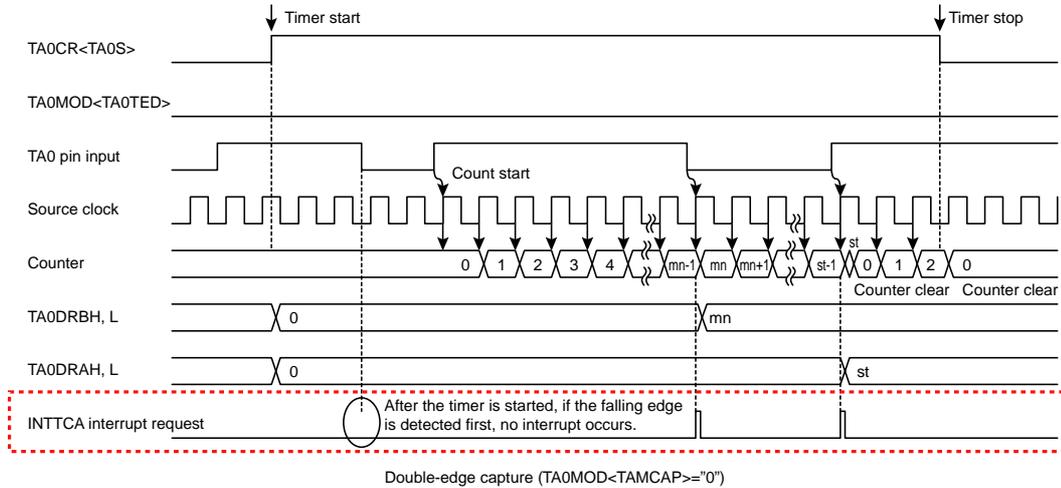
### Before correction

- The timing diagram for double-edge capture indicates that no interrupt request occurs at the count start edge after the timer is started. This should be corrected so that an interrupt request occurs at the count start edge, as shown below.
