## **Important Notices**

## **Restriction on Use of 8-bit Timers**

With regard to our TLCS-900/L1 Series and TLCS-900/H1 Series of 16-bit microcontrollers, we have found that the following problem may occur when 8-bit timers are used under certain conditions.

## Datasheet Modifications: PWM Cycle of 8-bit Timers

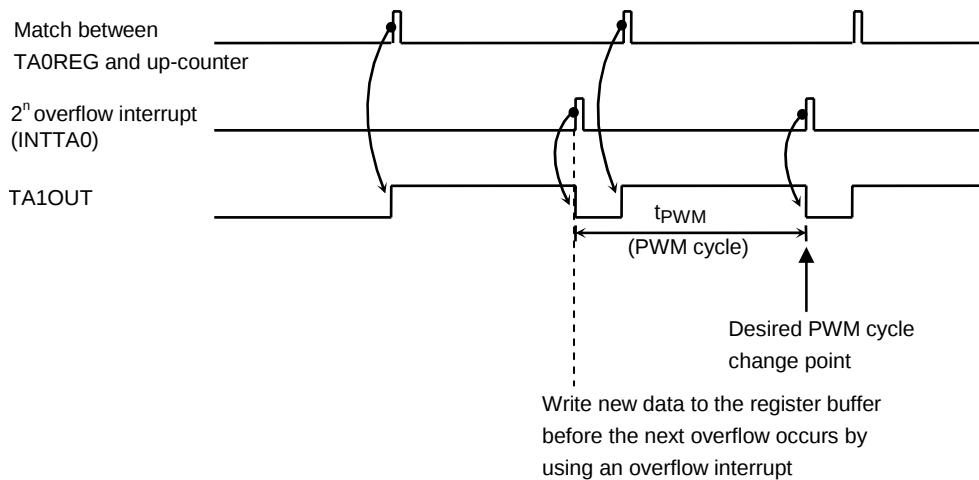
### Example when using PWM mode

When the double buffer is enabled for an 8-bit timer in PWM or PPG mode, caution is required as explained below.

If new data is written to the register buffer immediately before an overflow occurs by a match between the timer register value and the up-counter value, the timer flip-flop may output an unexpected value.

For this reason, make sure that in PWM mode new data is written to the register buffer by six cycles ( $f_{\text{sys}} \times 6$ ) before the next overflow occurs by using an overflow interrupt.

In the case of using PPG mode, make sure that new data is written to the register buffer by six cycles before the next cycle compare match occurs by using a cycle compare match interrupt.
