## **Important Notices**

**TOSHIBA Microcontrollers 900 Family**

## **Restriction on Use of 8-bit Timers**

**Datasheet Modifications: PWM Cycle of 8-bit Timers**

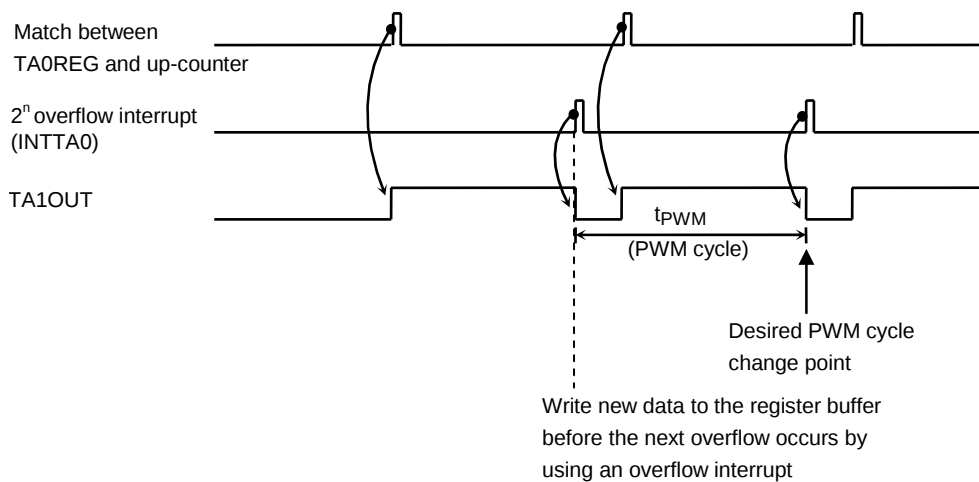
### Example when using PWM mode

If the timer register of an 8-bit timer is updated under the following conditions, the timer flip-flop may output an unexpected value.

- When the 8-bit timer is used in PWM or PPG mode
- When the double buffer is enabled
- When the data in the register buffer is updated immediately before an overflow occurs in the up-counter

If new data is written to the register buffer immediately before an overflow occurs by a match between the timer register value and the up-counter value, the timer flip-flop may output an unexpected value.

For this reason, make sure that in PWM mode new data is written to the register buffer by six cycles ( $f_{\text{sys}} \times 6$ ) before the next overflow occurs by using an overflow interrupt.

In the case of using PPG mode, make sure that new data is written to the register buffer by six cycles before the next cycle compare match occurs by using a cycle compare match interrupt.

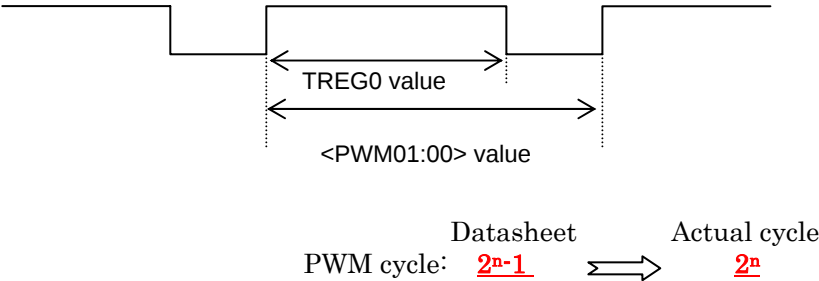
**[Operation]**  
Waveform in PWM mode (in the case of 8-bit timer TMRA01)

**[Modifications to be made]**  
In the datasheet the PWM cycle of 8-bit timers when used in PWM mode is described as “ $2^n-1$ ”. This should be corrected to “ $2^n$ ” as shown below.

PWM cycle  
00: Reserved  
01:  $2^6$   
10:  $2^7$   
11:  $2^8$
