July 2005

**TOSHIBA Microcontrollers 900 Family**

## **Restriction on Use of 8-bit Timers**

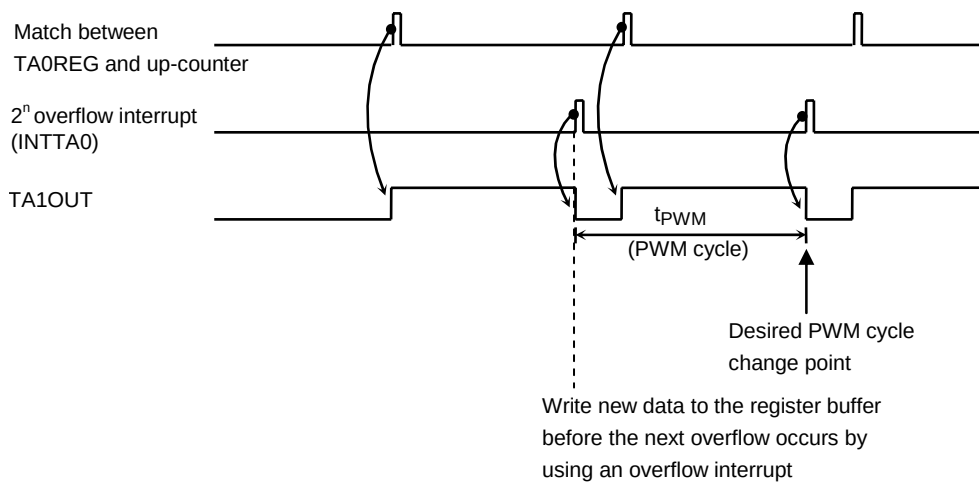
### Example when using PWM mode

If new data is written to the register buffer immediately before an overflow occurs by a match between the timer register value and the up-counter value, the timer flip-flop may output an unexpected value.

For this reason, make sure that in PWM mode new data is written to the register buffer by six cycles ( $f_{\text{sys}} \times 6$ ) before the next overflow occurs by using an overflow interrupt.
