July 2005

TOSHIBA Microcontrollers 900 Family
(TMP91CW12F) (TMP91PW12F) (TMP91CW12AF) (TMP91FY12AF) (TMP91C815F) (TMP91C016F)
(TMP91CW18AF) (TMP91PW18AF) (TMP91C219F) (TMP91C820AF) (TMP91CY22F)
(TMP91FY22F) (TMP91C824F) (TMP91C025F) (TMP91CK27U) (TMP91CP27U)
(TMP91CP27RUG) (TMP91CU27U) (TMP91CU27RUG) (TMP91FY27U) (TMP91CW28FG)
(TMP91CY28FG) (TMP91FY28FG) (TMP91C829F) (TMP91C630F)
(TMP92C820FG) (TMP92CH21FG) (TMP92CM22FG) (TMP92CA25FG) (TMP92CM27FG)
(TMP92CD54IF) (TMP92FD54AIF)
(TMP94C241CF) (TMP94C251AF)

Restriction on Use of 8-bit Timers

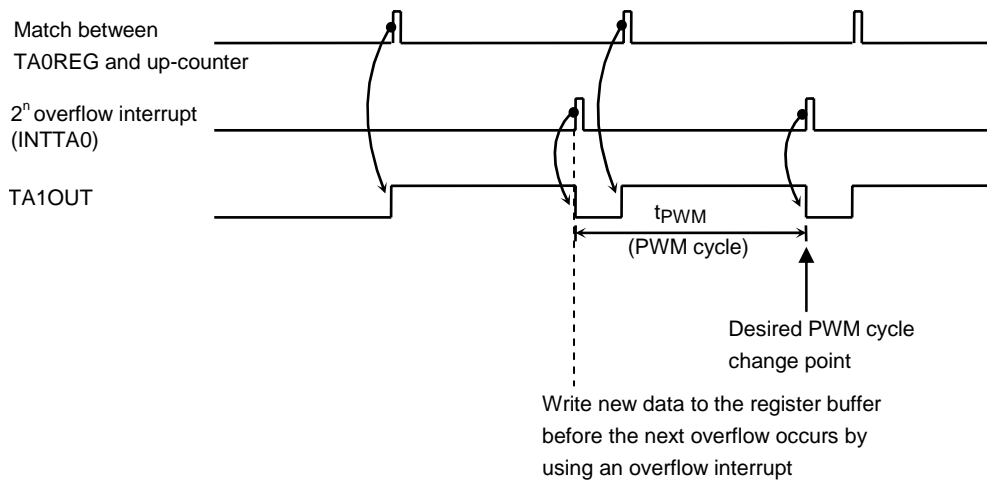
Example when using PWM mode

If new data is written to the register buffer immediately before an overflow occurs by a match between the timer register value and the up-counter value, the timer flip-flop may output an unexpected value.

For this reason, make sure that in PWM mode new data is written to the register buffer by six cycles ($f_{sys} \times 6$) before the next overflow occurs by using an overflow interrupt.

In the case of using PPG mode, make sure that new data is written to the register buffer by six cycles before the next cycle compare match occurs by using a cycle compare match interrupt.
